### **CLARK HOUSE - BUILDING STUDY**

### TOWN OF PENFIELD, NY

### PENFIELD CLARK HOUSE **BUILDING STUDY**

### THE CLARK HOUSE: STRUCTURAL CONDITIONS REPORT

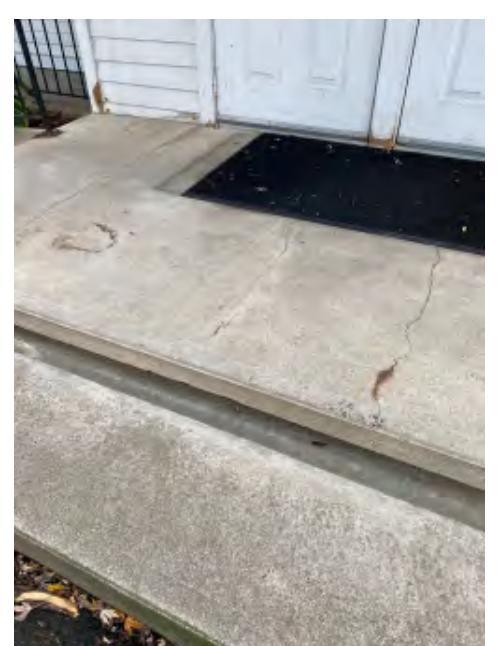
Photo 3 Cracks in concrete slab at the north entrance porch.

- We observed cracks in the concrete slab forming the stoop of the covered, Main-Entry Porch on the north side. The corner-post trim is deteriorating at the bases. The paint is also peeling on the clapboards/trim of the entranceway just above the stoop slab. The cast-iron railings around the porch and the ramp are also beginning to rust. (see Photos 3 & 4, below)
- 2. Stair C (roofed, open to the exterior), leading down to a basement entrance, exhibits similar deterioration at the bases of its porch posts and rusting at its cast iron railings, as does the nearby Main Entry Porch. Also, the downspout attached to the eastern-most post has been cut short, dumping water into the constricted area between the foundation and the adjacent ramp, contributing to the deterioration of the existing finishes. In time, this will damage the foundation walls of both. (see Photo 5 below)

**3) Concrete Slabs**: Cracked concrete pads and slabs should be replaced with appropriate depth 4,000 psi reinforced concrete on properly compacted fill. Care should be taken that snow removal techniques be used that do not involve the use of sodium chloride which will damage exterior concrete surfaces and rust iron railings.

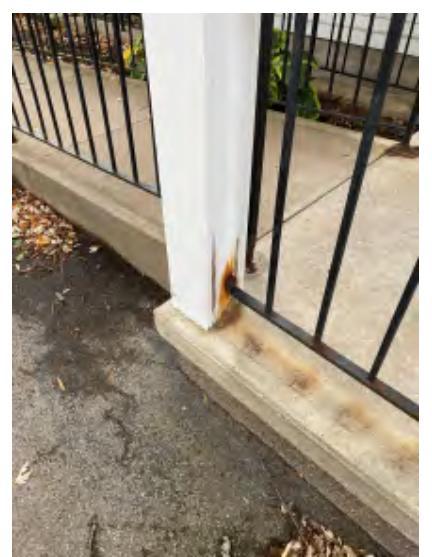
Photo 4 NE post-base and nearby railing.

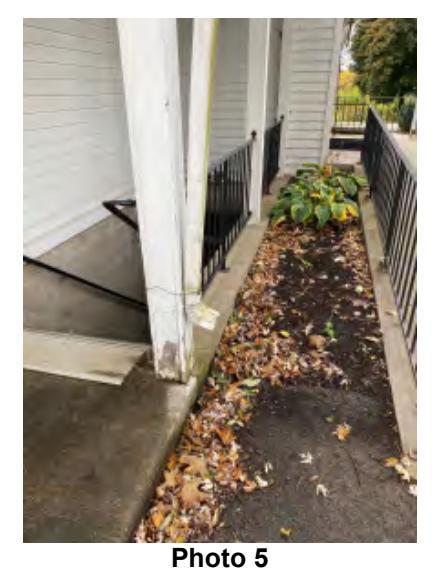
Deteriorating base at east-end column supporting roof over Stair C areaway to basement.

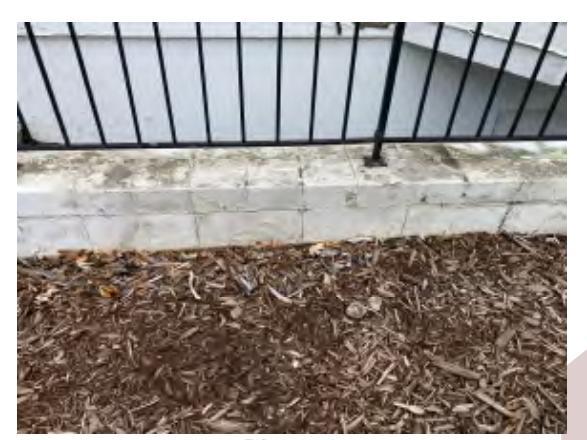
Photo 8
 Image: Close-up of outer Stair D foundation wall (located at NW corner of Pro Shop). Stairway leads to Basement Locker Rooms, etc.

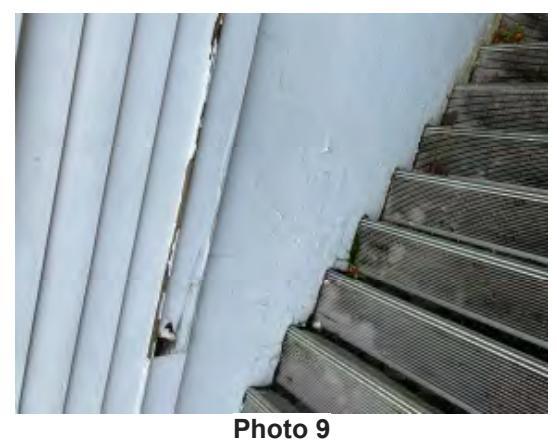
View of rotting sill-plate and trim at west wall of Pro Shop above Stair D.

**1) Sill Beams and Sill Plates**: Replace all rotting/damaged sill-beams and sill-plates with same-depth Parallam structural members. Pressure-treated plates and/or pressure-treated structural members may also be used in appropriate locations.

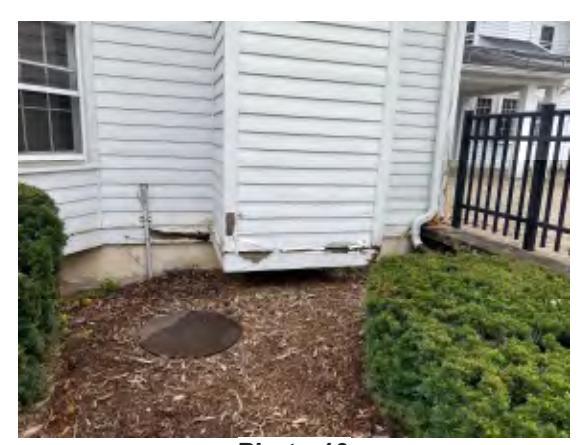
Photo 10 Deteriorating sill plates and trim at bump-out on west wall of Pro Shop near SW corner.

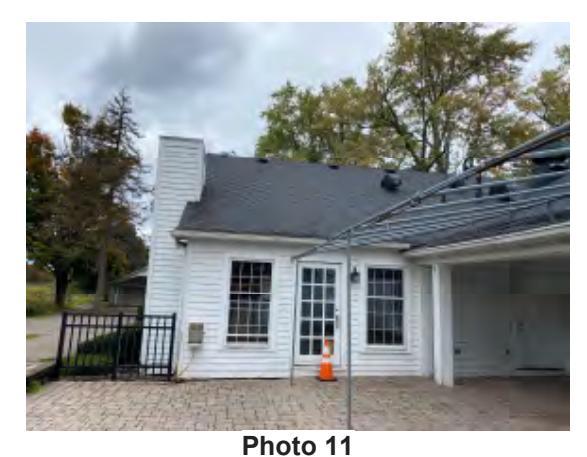
The sill-plate and trim is also rotting as far as the doorway at the south Pro Shop wall where it abuts the patio. Note that the bases of the patio posts are also deteriorating.

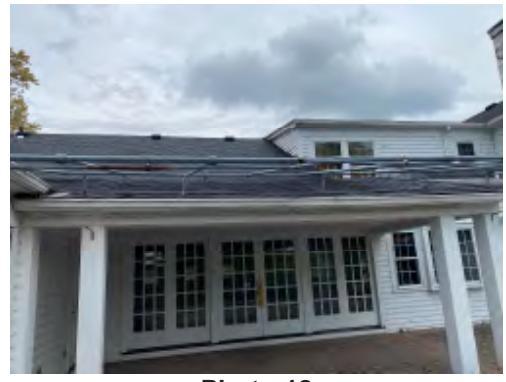
- 4. The roof over the West Patio (above the French doors leading from the first-floor Bar/Restaurant) is sagging in the center. (see Photo 12 below) Reinforcement of roof members, will be required.

View of the roof over the Patio (at the west wall of the central Bar/Dining Room) showing the sag in the center of the roof.

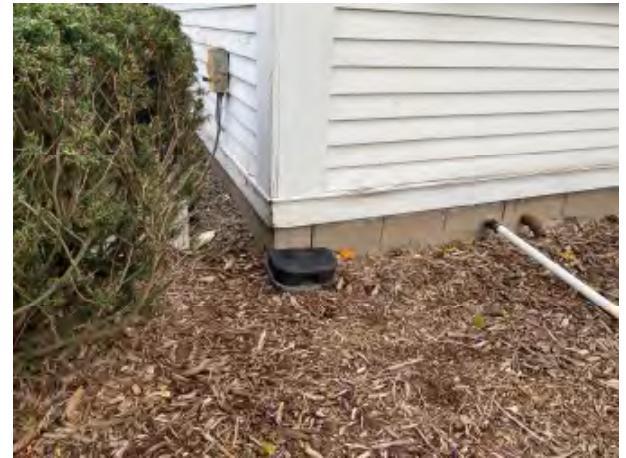
- 1. The concrete-block foundation under the former unexcavated west-end porch, which became the west end of the golf club Living Room, requires repointing on the south. (see Photo 14 below)

SW corner of Clark House foundation (at former open porch, now a part of the Living Room). Note concrete block is in need of repointing; sill trim is beginning to deteriorate, especially at the corner.

**6) Masonry Repointing:** Repoint block and re-grout stone masonry where required. Replace damaged or missing stone in kind. Mortar to match existing.

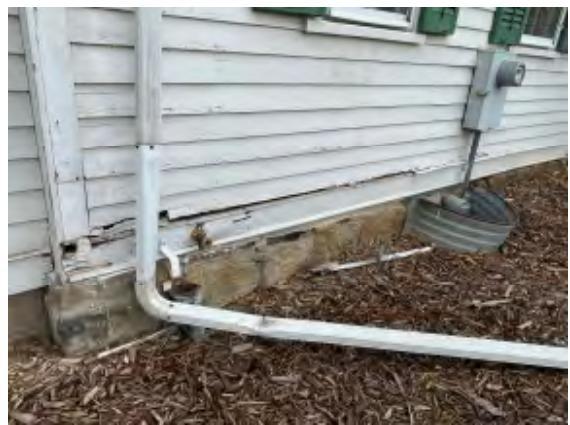
Photo 15

SW corner of original 1832 Clark House stone foundation. Rotting timber sill-beam ,trim, and clapboard at corner. Base of the First-Floor corner-post in this location may also be deteriorated.

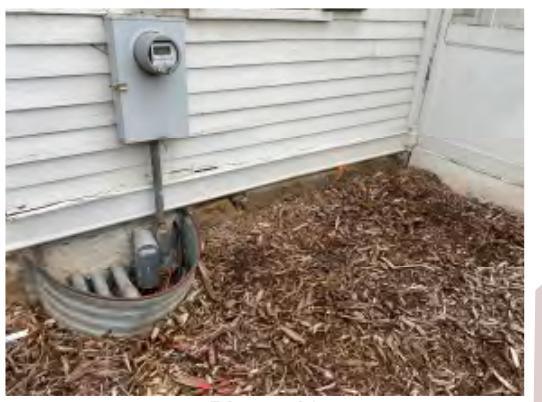
Photo 16
 Image: Continuation of south wall of original stone foundation. Note entrance portico, at right. note that drip-edge above trim is catching water.

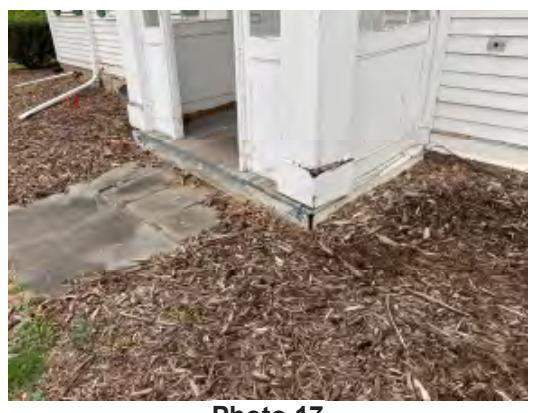
Photo 17 South entrance portico looking west. Notice poor condition of the portico floor.

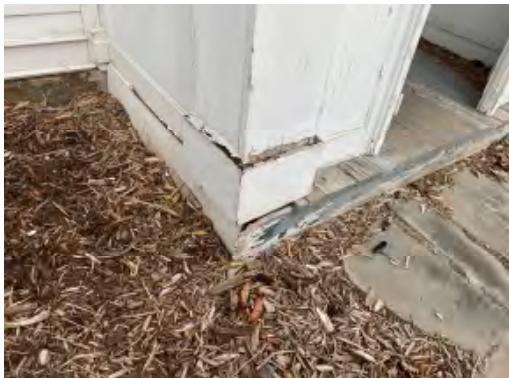
Photo 18 Close-up of SW column-base at entrance portico.

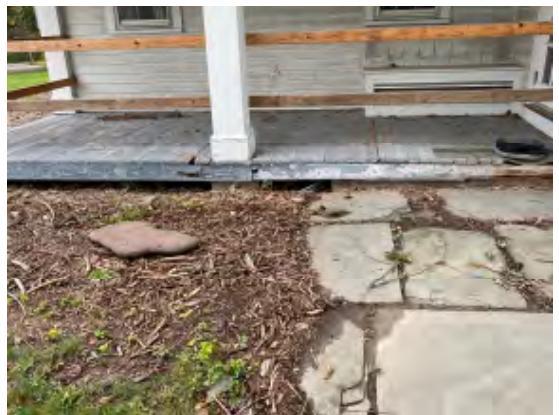
Photo 21

- 1. TSE found that the wooden porch-floor at the east-end of the original house, and the foundations below the wood columns are beginning to fail. (Note that there is a former areaway leading to the basement below the porch structure in the north corner,) The columns and roof/ceiling assembly of the east porch appear to be in good condition, however. (see Photos 21 & 22 below)
- 2. The timber sill-beam along the east wall of the central Bar/Dining Room is rotting due to exposure to ground moisture, weather, and snow accumulation. (see Photo 23 below)
- 3. The sill-beams and plates along the rest of the east foundation wall further north, also appear to be deteriorating at all of the successive additions. (see Photo 24 below)

Open porch on the east end of House exhibits a failing floor structure and unstable column foundations. Note bench structure covering former areaway opening to basement.

**4) Wood Porches:** The existing wood porches are each near, or at, grade and should be replaced using full-perimeter block foundations to a minimum depth of 48" (or to the depth of undisturbed soil near the basement foundations). See concrete-slab recommendations. For the appearance of wooden porch floor-boards, a stamp may be used with colored concrete, or, possibly, the concrete pads may be surfaced with a material such as composite decking (i.e. Trex).

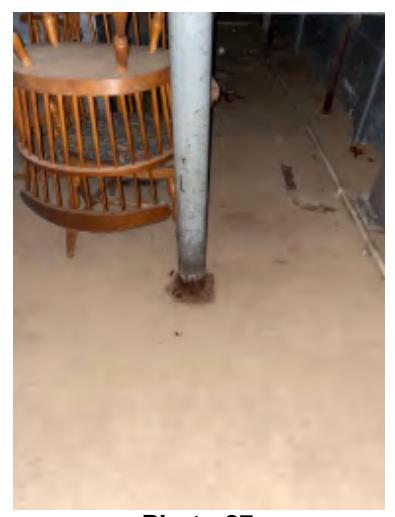
Photo 27 Rusting base of pipe column east of Stair A.

**2)** Column Replacement: Replace rusted pipe columns and all temporary jack-posts with new steel pipe columns having plates at top and bottom for proper attachment to the structure above and below. The new columns will need to be supported on new concrete footings.

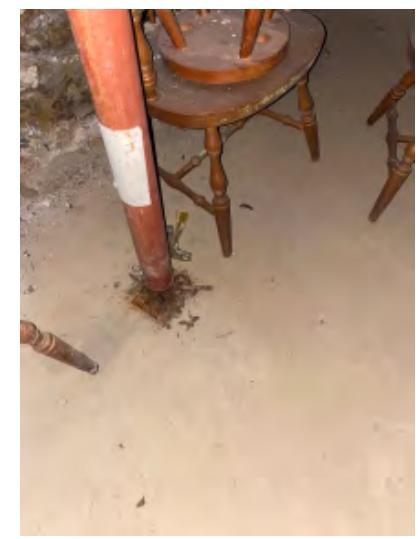
Photo 29 Closeup of rusting jack-post base. Post pictured above in Photo 28.

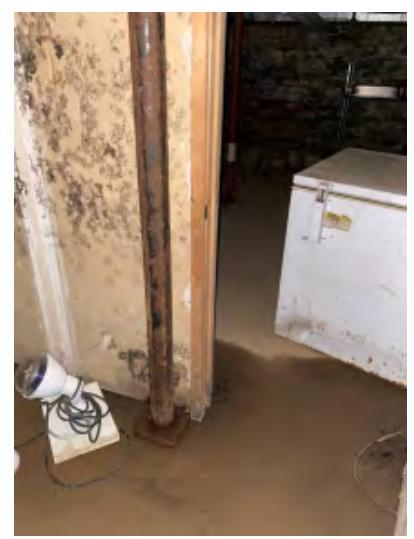
- 3. The storage room in the basement addition on the north-east side of the house has a very wet floor. The cause of this standing water remains to be verified. This is a critical investigation since the jack posts here were found to have rusted bases (as were those nearby: see item 2, above). A crock/sump pump with under-slab drains in this area may be required to protect the structure on this end of the basement. Please note that the floor at the west end of the basement, which has an existing, sump-crock, appeared to be dry. (see Photos 30, 31, & 32 below).

Photo 30 Jack-post with rusted base just inside basement storeroom doorway.

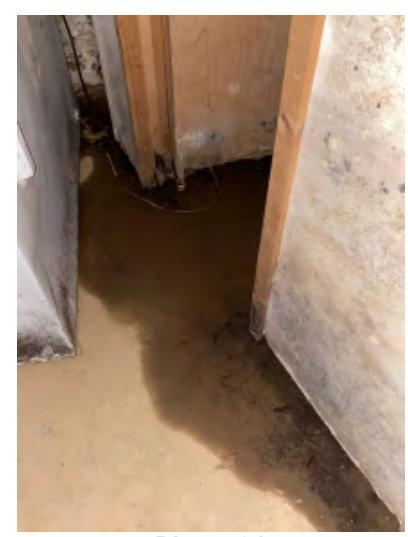
Photo 31 Water on floor at entrance to basement storeroom.

**8)** Forensic Structural Investigations: There are also some forensic structural investigations that should be performed in order to: 1) pinpoint and deal with the source of water on the east side of the original basement; 2) to assess the support of the Bar/Dining Rooms over the central crawl space; and 3) address the flexural/movement problems found in the Pro Shop ceiling/roof assembly and several nearby ceilings on the west side of the building.

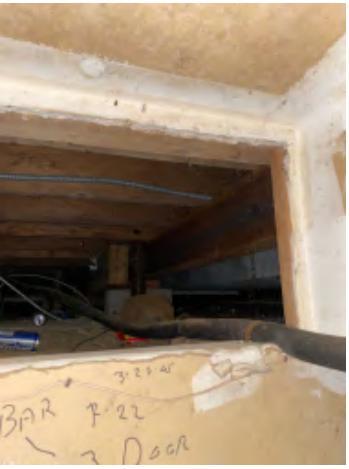
### Photo 33

- 4. The crawl space under the center Bar/Dining Room floor is supported by an eclectic variety of posts and beams added as a result of the numerous growth spurts of the building during the 20<sup>th</sup> century. These are visible from the areaway openings found in the basement storeroom addition. These crawl-space posts and foundations will need to be assessed for possible reinforcement and/or replacement in the next level of study. (see Photos 33 & 34 below)

View of crawl space under center Bar/Dining Room looking north from streroom. Note wood post and beam on block footing. Foundation of the nearby pipe column is in doubt.

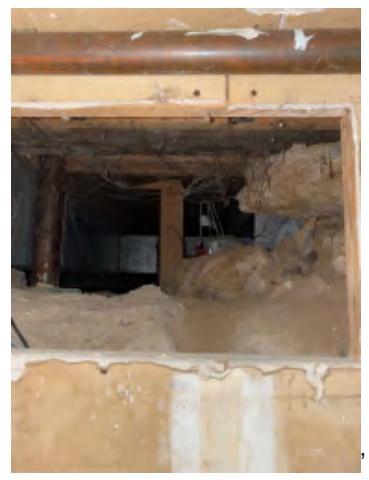
### Photo 34

View of same crawl space looking west from storeroom. Note pipe column and wood post (with shim).

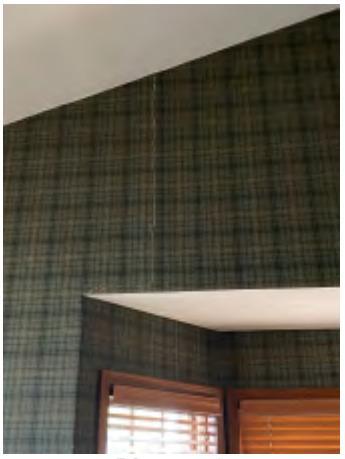
Photo 42

Crack above the bay window in the Pro Shop. View at the south end of the window, looking west.

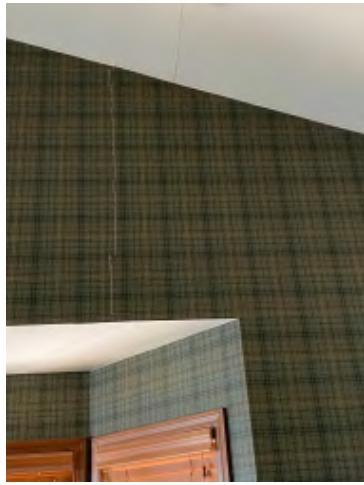
Photo 43

Similar crack above the bay window at the north end of the bay window. Note off-set ceiling crack above.

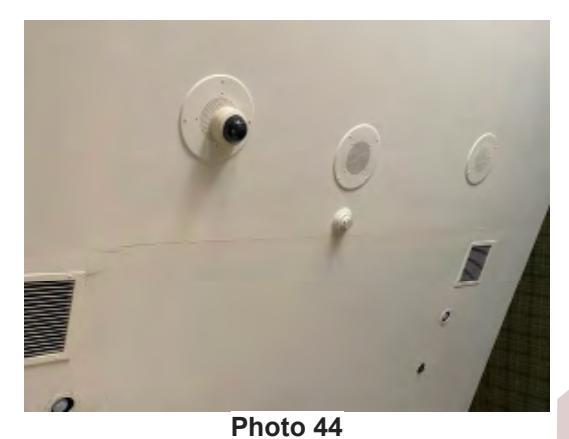
Crack in ceiling at north end of bay looking toward east wall of Pro Shop. (A similar crack has appeared at the south end of the bay window, also).

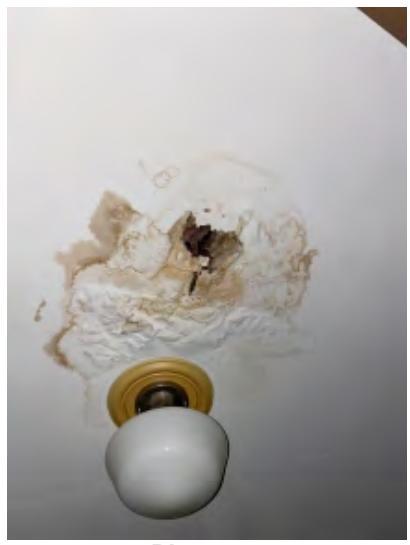
Photo 45 View of water damage to Men's Room ceiling.

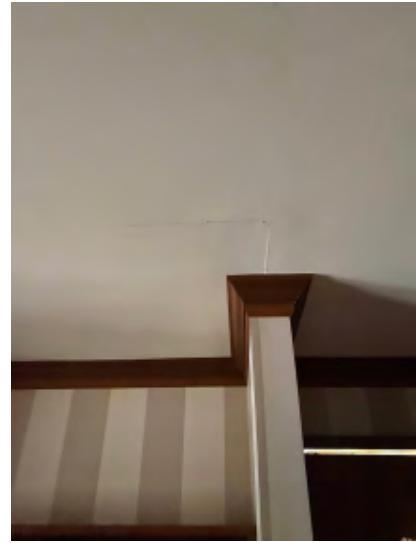
- 6. We found cracks in the ceiling on both sides above the south opening to the Foyer (near Stair B). (see Photo 46 below) These cracks may also be a part of the Pro Shop roof movement since the ridge ends on the level above, almost directly over the center of the south entrance to the Foyer on the first floor.

View of L-shaped crack in Foyer ceiling, looking east. (Entrance to Kitchen, at right.) Note: there is also a straight-line crack in the ceiling on the opposite side of the Foyer.

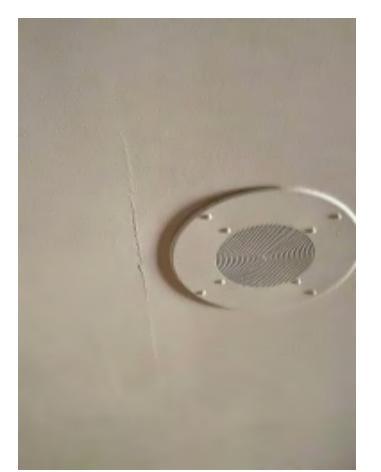
- 7. A 36" long ceiling crack was observed in the ceiling above the Hallway next to Stair B where it ascends to the second floor. (see Photo 47 below)
- 8.

View of crack in the first-floor ceiling next to Stair B.

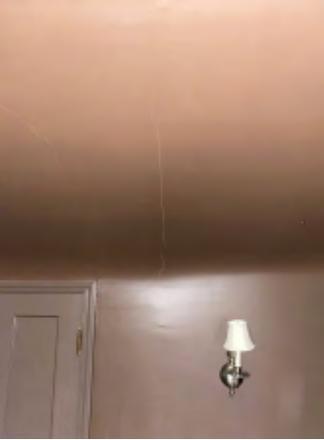
Photo 48

Cracks in the sloped ceiling next to the west wall of the second-floor Club Room (near storeroom door).

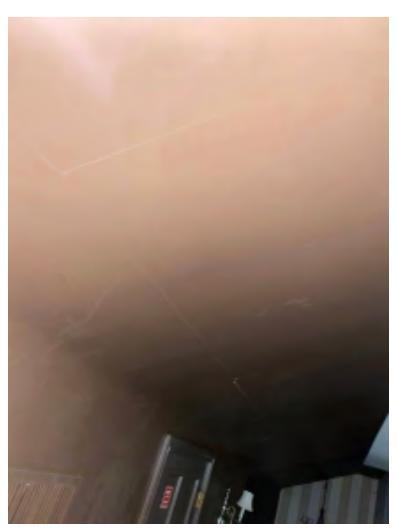
Photo 49
 Extensive cracking in the same sloped ceiling (taken further south of Photo 48), looking NW toward head of Stair B.

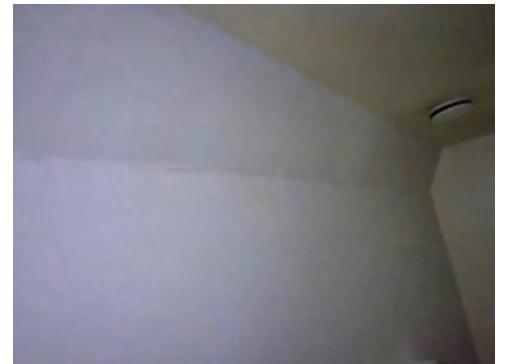
#### Photo 53

- 4. There is a crack in the ceiling in the Office along the line where the flat ceiling meets the sloped ceiling. **(see Photo 53)**

Crack in the ceiling of the second-floor Office, where the flat ceiling meets the sloped ceiling on the north side of the room.

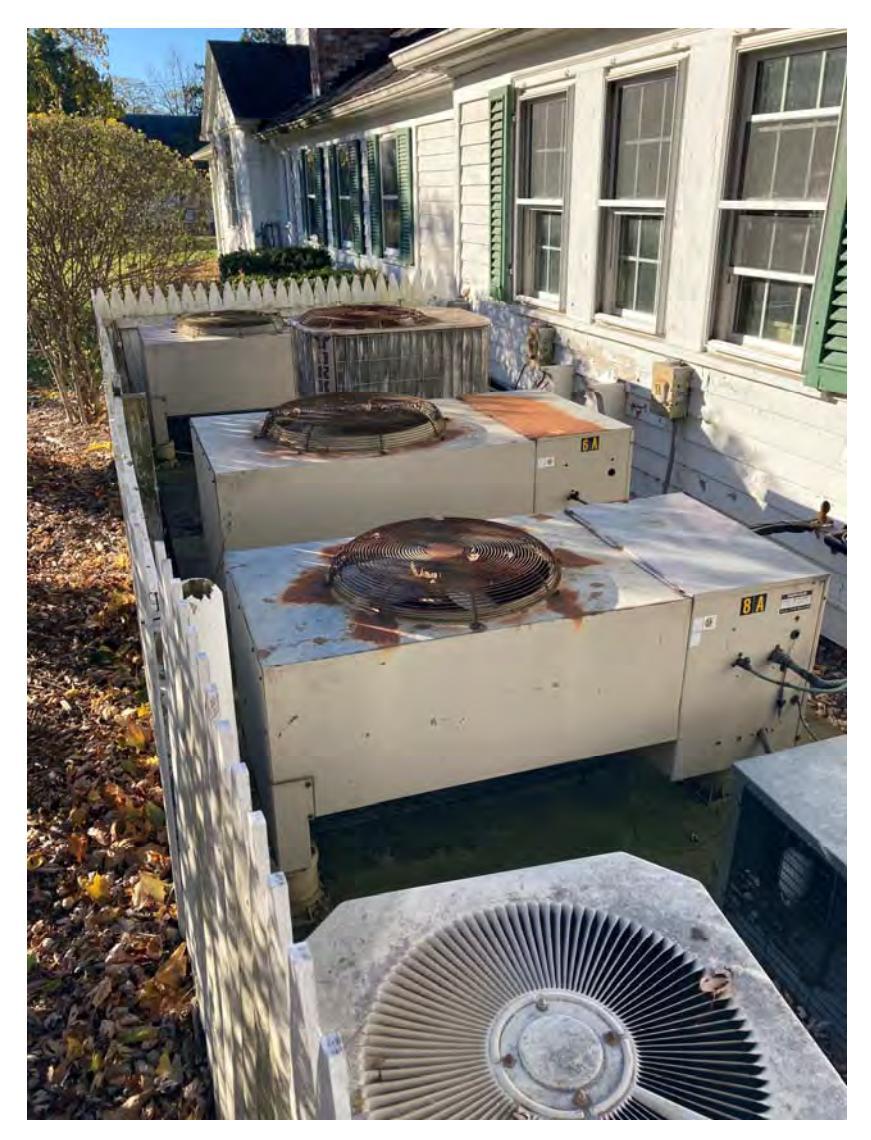
c. All mechanical units appear to be nearing the end of their expected lifespan. Particularly, condensing units on the exterior are covered in rust.

3) Furnace systems: A new, high efficiency (95% AFUE or greater) condensing gas furnaces should replace the existing units. The ductwork would be reused, and airflow should approximately match existing systems to maintain air throw and distribution throughout the building. MERV 13 filters would be installed in a 4" filter housing. New condensing units with new linesets (as required due to new refrigerant being used) and new cooling coils would update an old technology with more efficient, reliable, and guieter cooling. New thermostats may be required, especially for multi-stage or modulating heating or cooling. Thermostats would be seven-day programmable. Since the occupancy is expected to be similar, the heating and cooling capacities of the systems do not need to change.

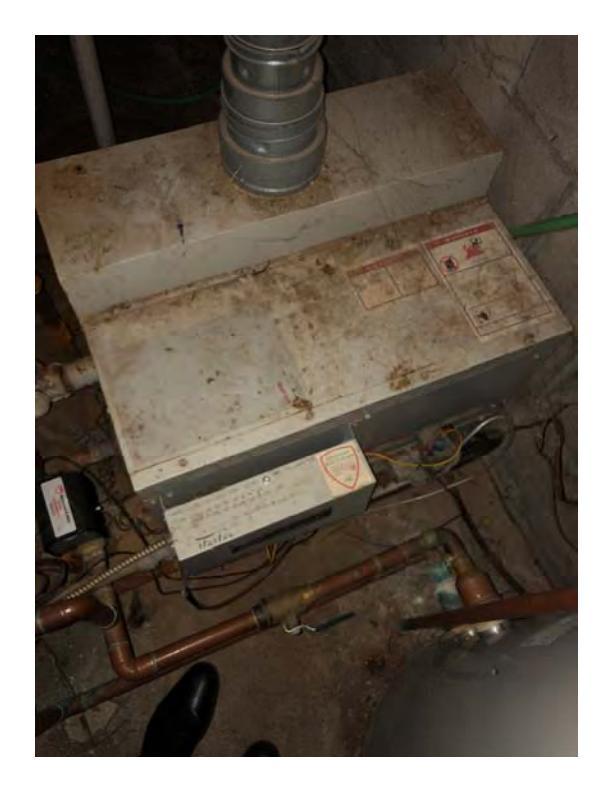
Lochinvar Boiler

1. The domestic hot water system is currently comprised of a gas-fired boiler and an 80 gallon storage tank located in a storage room in the north basement's northeast corner. There is currently no domestic hot water recirculation system. The storage tank is adequately sized for the proposed use of the building and is in good condition. The boiler is 14 years old and appears to be on the verge of needing to be replaced.

**3) Replace Boiler:** Replace the existing gasfired domestic water boiler with a new, 95% AFUE gas-fired domestic water boiler. The pump and piping between the boiler and existing storage tank shall also be replaced. Set the storage tank to 140°F. Mix down the 140°F hot water with domestic cold using a thermostatic mixing

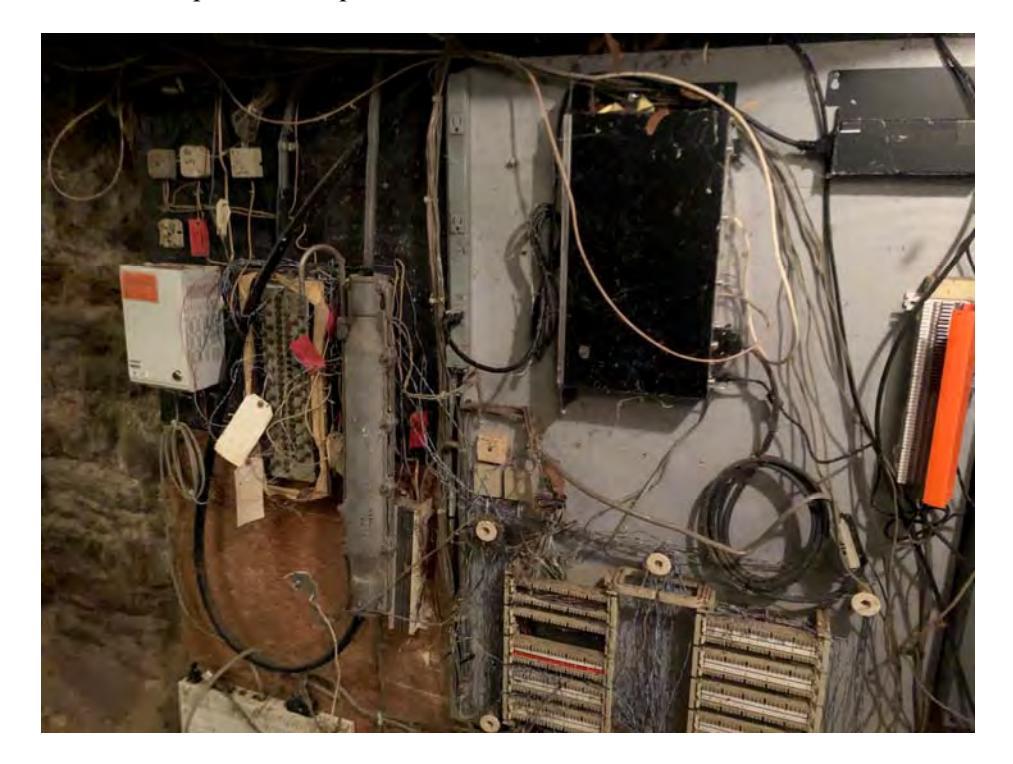
1. The South Basement has a plywood telephone terminal board located adjacent the electric service. The telephone and CATV service from Frontier and Spectrum terminate at this telephone terminal board. The existing multi-pair telephone cable and the CATV coaxial cable entering the building may be reused. All existing telephone and CATV equipment and cabling after the utility demarcation point is antiquated and should be removed.

Telephone and CATV Service Entrance Equipment.
