### **CLARK HOUSE - BUILDING STUDY**

### TOWN OF PENFIELD, NY

### PENFIELD CLARK HOUSE **BUILDING STUDY**

### THE CLARK HOUSE: STRUCTURAL CONDITIONS REPORT

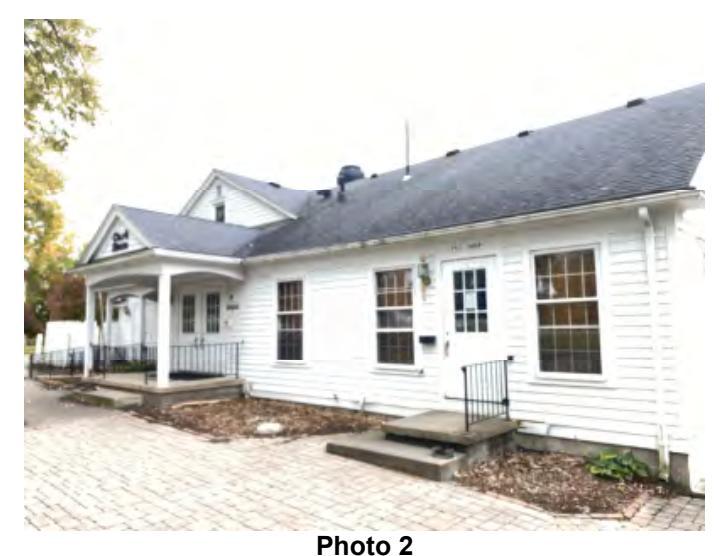
North Facade: the primary entrance to the former Golf Club from the parking lot.

- We observed cracks in the concrete slab forming the stoop of the covered, Main-Entry Porch on the north side. The corner-post trim is deteriorating at the bases. The paint is also peeling on the clapboards/trim of the entranceway just above the stoop slab. The cast-iron railings around the porch and the ramp are also beginning to rust. (see Photos 3 & 4, below)
- 2. Stair C (roofed, open to the exterior), leading down to a basement entrance, exhibits similar deterioration at the bases of its porch posts and rusting at its cast iron railings, as does the nearby Main Entry Porch. Also, the downspout attached to the eastern-most post has been cut short, dumping water into the constricted area between the foundation and the adjacent ramp, contributing to the deterioration of the existing finishes. In time, this will damage the foundation walls of both. (see Photo 5 below)

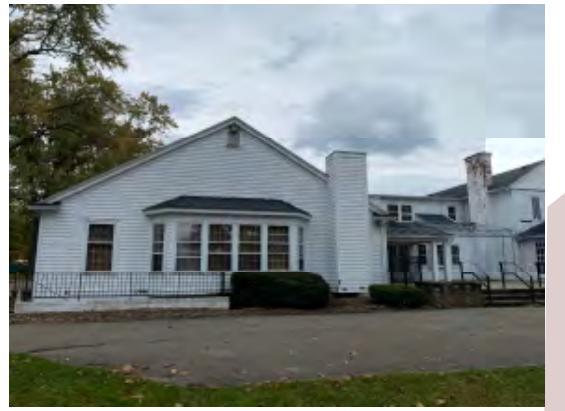
Photo 6 West Facade: note Pro Shop, at left, with bay window.

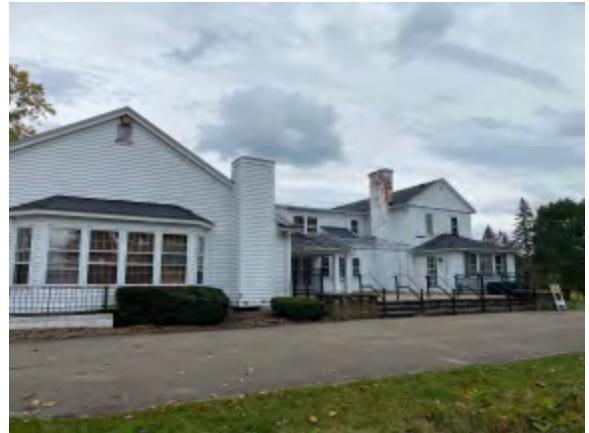
West Facade: note Patio (center) and the original Clark House, at right, with one-story enclosed porch at the gable-end.

- 5. The brick chimney on the north wall (west side) of the original Clark House is beginning to exhibit weathering at the top. Install a new shield over the chimney cap to protect the masonry and keep out the elements. (see again, Photo 7 below)

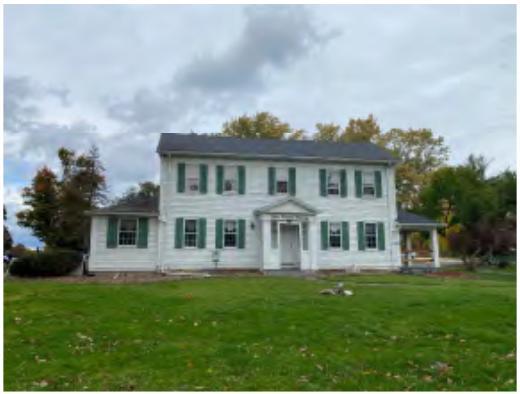
Photo 13

South Facade of the original Clark house from Clark Road. Note entrance portico, at center.

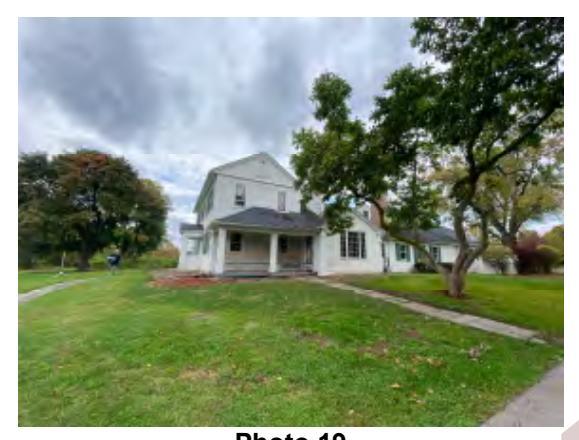
Photo 19 East Facade of the original Clark House with attached east-end open porch in center of photo; the successive additions are to the right.

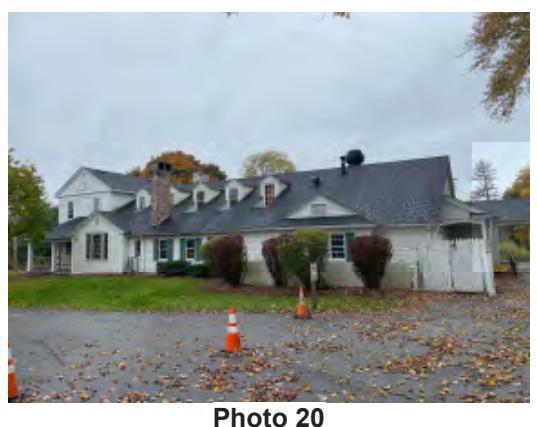
East Facade from the NE, showing the later additions to the original house (North Entry at far right.)

- 1. TSE found that the wooden porch-floor at the east-end of the original house, and the foundations below the wood columns are beginning to fail. (Note that there is a former areaway leading to the basement below the porch structure in the north corner,) The columns and roof/ceiling assembly of the east porch appear to be in good condition, however. (see Photos 21 & 22 below)
- 2. The timber sill-beam along the east wall of the central Bar/Dining Room is rotting due to exposure to ground moisture, weather, and snow accumulation. (see Photo 23 below)
- 3. The sill-beams and plates along the rest of the east foundation wall further north, also appear to be deteriorating at all of the successive additions. (see Photo 24 below)

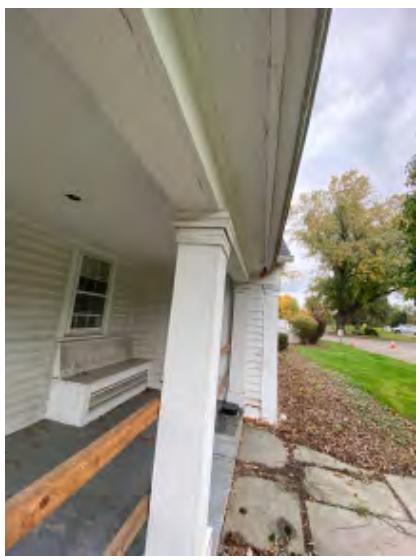
Photo 22 View of the east-end wooden porch posts and ceiling looking north.

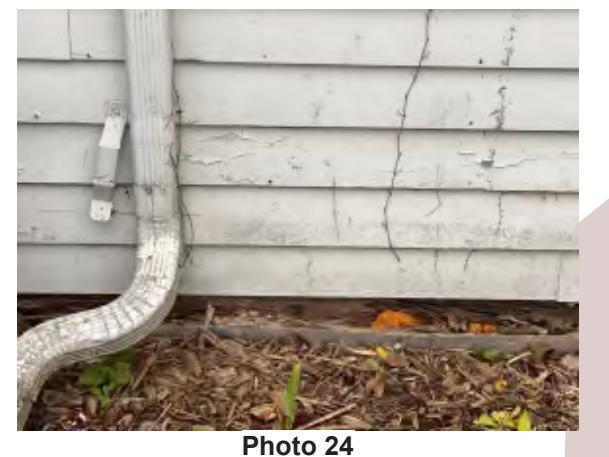
Close-up of rotting sill-plate and trim in contact with ground near the NE end of the building. Note mildew on clapboards.

**1) Sill Beams and Sill Plates**: Replace all rotting/damaged sill-beams and sill-plates with same-depth Parallam structural members. Pressure-treated plates and/or pressure-treated structural members may also be used in appropriate locations.

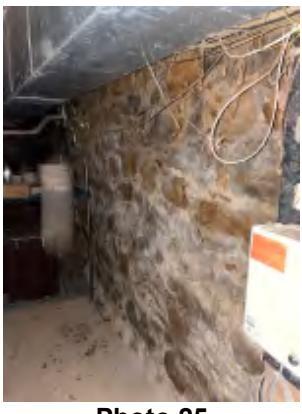
Photo 25

- 1. TSE found the stone foundation wall of the original basement to be in good condition. (see Photos 25 & 26 below)
- 2. The pipe column east of the basement stair and the jack post located further east in the original basement, support a central wood beam. Both columns are rusting at their bases. (see Photos 27, 28, & 29 below)

View of original stone foundation wall in basement (south center) looking east.

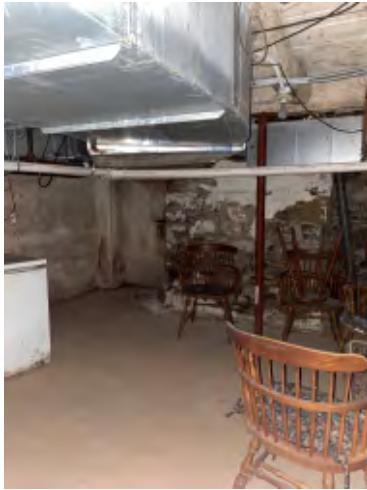
Photo 28

View of east-end of Clark House basement. Note door to former areaway in end wall and jackpost supporting wood beam near chairs in background.

**2)** Column Replacement: Replace rusted pipe columns and all temporary jack-posts with new steel pipe columns having plates at top and bottom for proper attachment to the structure above and below. The new columns will need to be supported on new concrete footings.

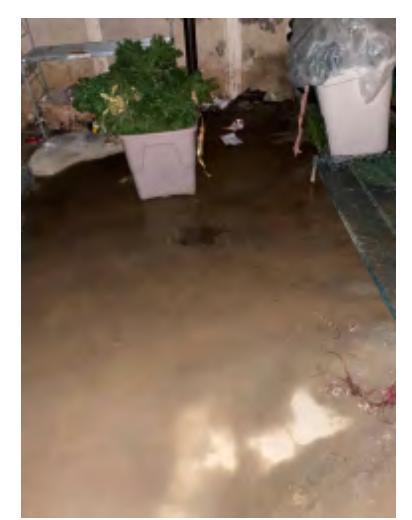
- 3. The storage room in the basement addition on the north-east side of the house has a very wet floor. The cause of this standing water remains to be verified. This is a critical investigation since the jack posts here were found to have rusted bases (as were those nearby: see item 2, above). A crock/sump pump with under-slab drains in this area may be required to protect the structure on this end of the basement. Please note that the floor at the west end of the basement, which has an existing, sump-crock, appeared to be dry. (see Photos 30, 31, & 32 below).

Photo 32 Storeroom floor looking north showing standing water.

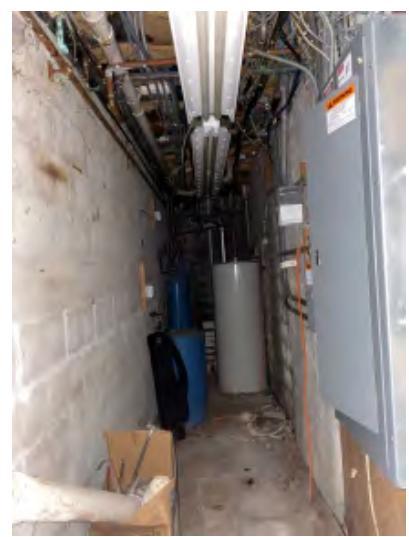
- 1. TSE found the concrete-block foundation walls of the basement under the later additions at the north end of the facility to be in good condition; including the retaining walls on either side of Stairway C. (see Photos 35, 36, & 37 below)

Photo 35 View looking east in storage/mechanical area of basement next to Stair C.

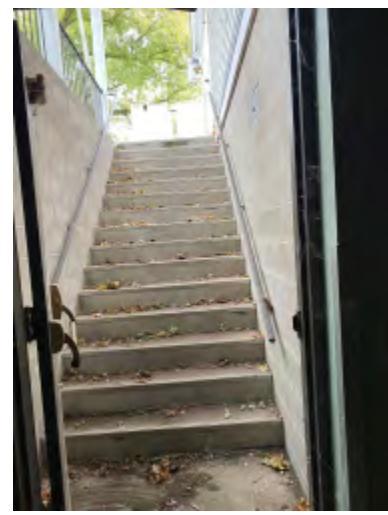
Photo 36

View of Stair C steps and foundation walls looking east from open North Basement door.

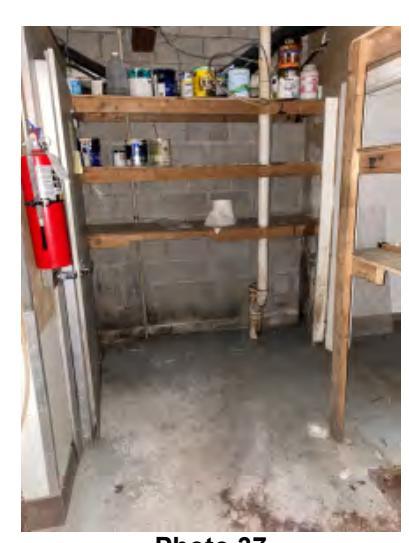
Photo 37

View of concrete block wall in interior basement storage room looking south (next to Stair B).

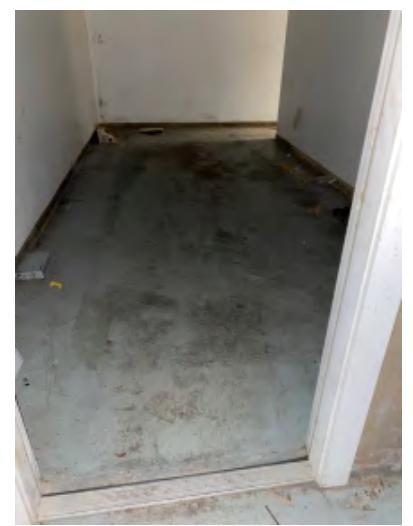
#### Photo 38

- 2. The concrete floor-slab of the North Basement was dry throughout, and appeared to be in good repair, as did the steps of Stair C. (see Photo 38, and see again: Photos 35, 36, & 37 below)

Looking west from storage room into basement hallway south of Locker Rooms, leading to Stair D.

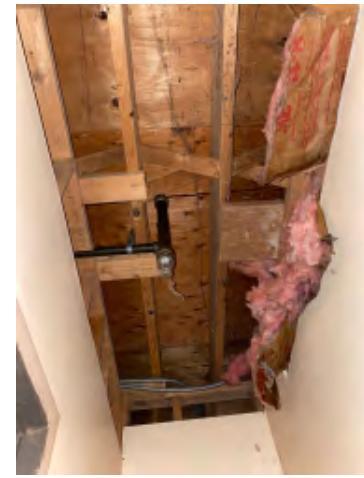
Photo 39

- 3. Due to the requirement for fire-rated ceilings over most of the North Basement rooms, the wooden first-floor structure was only completely visible for inspection above the storage room next to Stair C and the storage closet along the north hallway wall (the Kitchen Receiving area and the North Entry Vestibule are above them). Based upon what we were able to inspect, the first-floor structure of the latest addition appears to be in very good condition. (see Photo 39; see again Photo 35 below)

View from storage closet next to North foundation wall, looking up at wood first-floor structure of the North Vestibule), overhead.

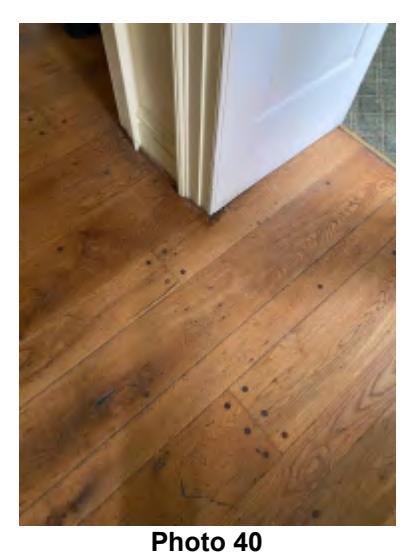
View of the center, first-floor Hallway of the original Clark House at the high-spot in the floor.

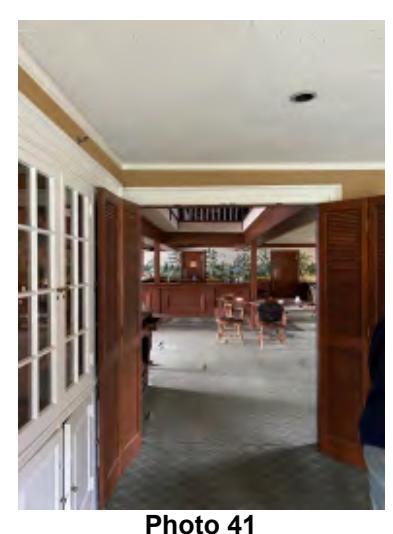
View looking north from the Clark House Dining Room into the central Bar/Dining Room of the Golf Club. Note that the header above the door drops to the left.

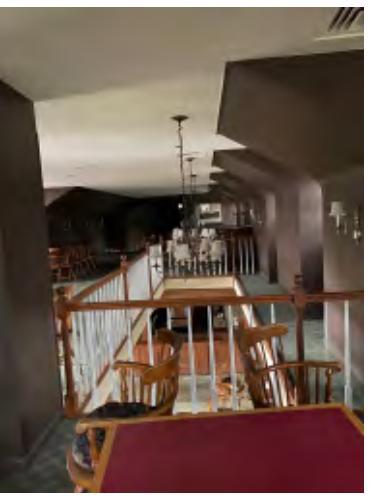
Photo 50

- 2. The two large openings in the Club Room floor at the second level may, or may not remain open, once the final decision regarding re-purposing of this building is made. (see Photos 50 and 51 below)

View looking north into Club Room from the East Dining Room of Clark House on the secondfloor. Note the opening to the first-floor at center and the dormer alcoves, to the right.

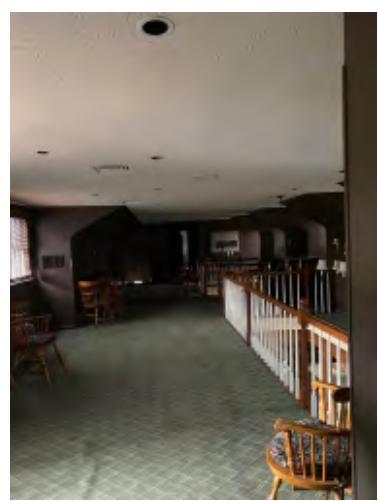
Photo 51

View of Club Room looking north from Stair A, Note both of the existing openings in the second floor on the right side of the photo.

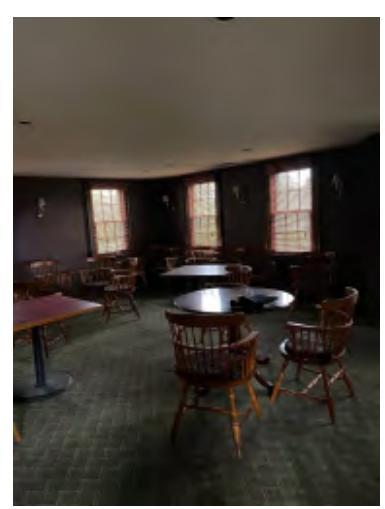
- 3. The East and West Dining Rooms on either side of Stair A, on the second floor of the original Clark House appear to be in good repair (see Photo 52) One small problem area should be investigated further in Level 2: the floor slopes slightly toward the front (south) wall for a short distance on the east side of a 30" +/- long N/S support that aligns with the west side of the Stair A and Living Room wall below.

Photo 52 The West Dining Room of the Clark House, looking SW.

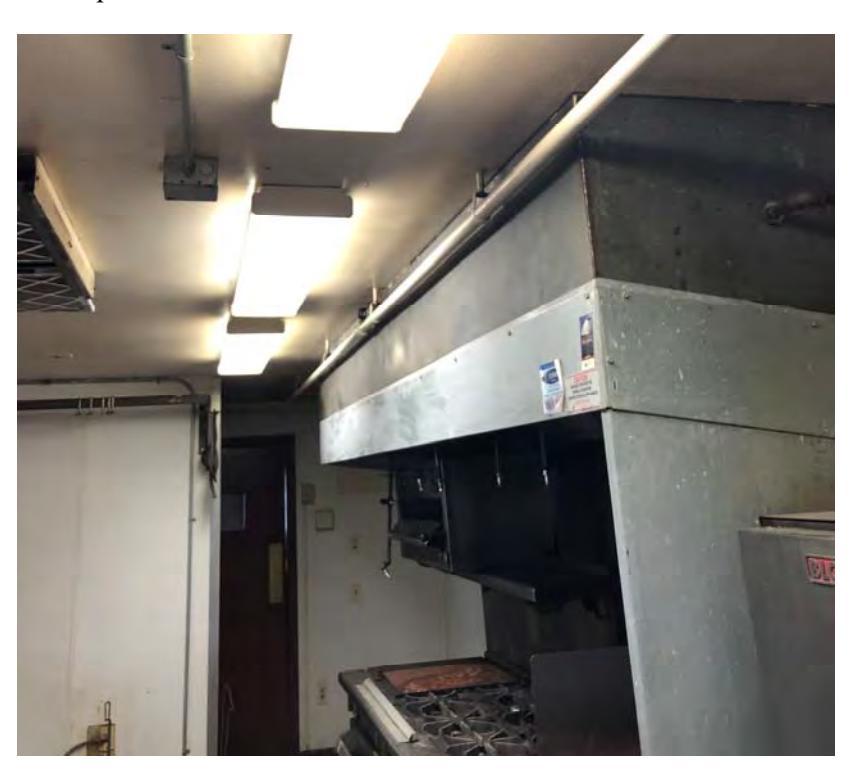
b. A commercial exhaust hood system exists in the kitchen. No makeup air unit is present.

c. All mechanical units appear to be nearing the end of their expected lifespan. Particularly, condensing units on the exterior are covered in rust.

The commercial kitchen hood and exhaust fan would be replaced with a new unit that meets the tenant's cooking requirements. Makeup air must be provided with such a system, but may be by a packaged makeup air unit or simply by a gravity opening such as a louver with a motorized damper, which appears to be the system in the existing kitchen.

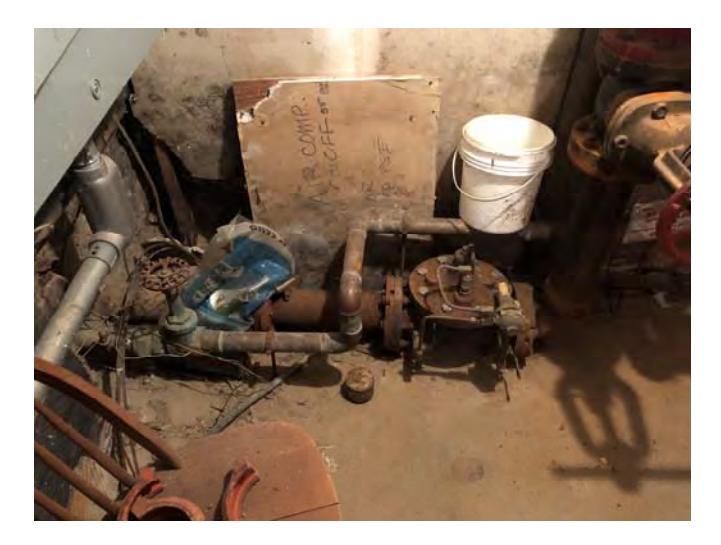
1. The building is currently served by a 2" copper domestic water service. Both the RPZ and the water meter were not located at the service entrance in the south basement, which indicates they are located out on the site either in a vault or in a hot box. The domestic water service is adequately sized for the proposed use of the building.

Incoming Domestic Water and Fire Services

2. A 4" steel fire service currently serves the building and enters via the south basement. The backflow preventer is out on the site in the hotbox or vault, but a single check valve is located inside. The fire service is adequately sized for the proposed used of the building.

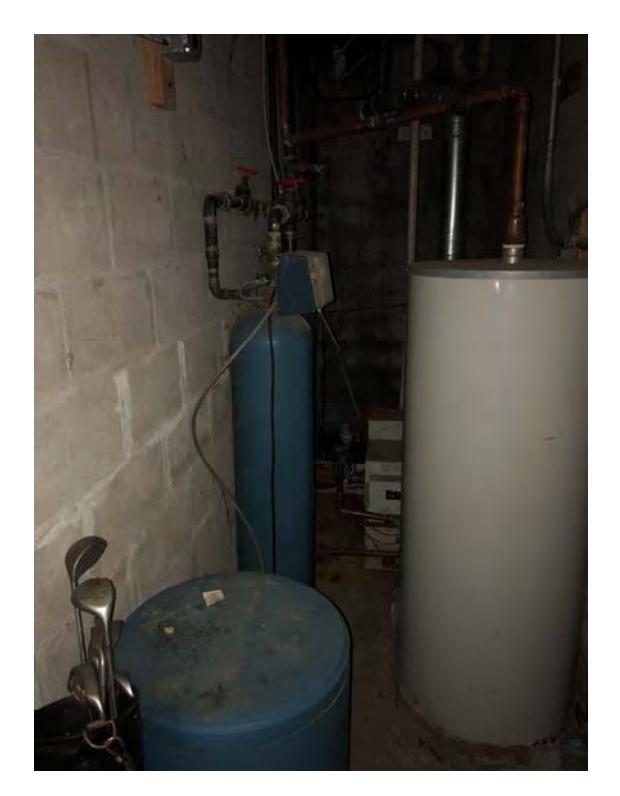
1. The domestic hot water system is currently comprised of a gas-fired boiler and an 80 gallon storage tank located in a storage room in the north basement's northeast corner. There is currently no domestic hot water recirculation system. The storage tank is adequately sized for the proposed use of the building and is in good condition. The boiler is 14 years old and appears to be on the verge of needing to be replaced.

How Water Storage Tank (right) and Water Softener System (left)

2. All existing domestic water piping is uninsulated. Current code requires all domestic water distribution piping be insulated based on the water temperature and size of the piping.

- 1. Replace the existing gas-fired domestic water boiler with a new, 95% AFUE gasfired domestic water boiler. The pump and piping between the boiler and existing storage tank shall also be replaced. Set the storage tank to 140°F. Mix down the 140°F hot water with domestic cold using a thermostatic mixing valve. Set the mixing valve outlet to 105°F and connect to existing hot water piping serving the bathrooms. Bypass the mixing valve with 140°F hot water and connect to existing domestic hot water piping serving the kitchen.

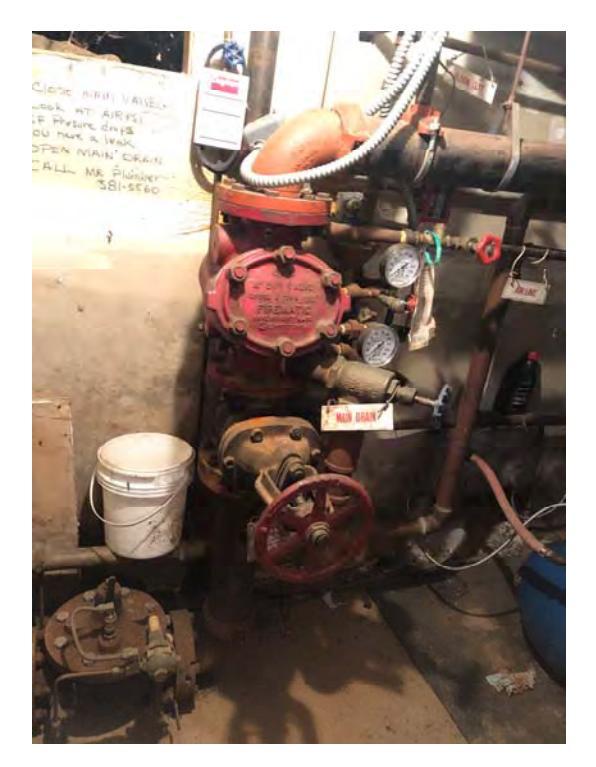
1. The building's fire protection system is a dry pipe system fed using (1) 4" riser check valve and an air compressor. The main drain is routed to the sump located in the northwest corner of the room. There are currently no tamper, flow, or pressure switches on the existing riser check valve. One of each should be added and wired to the building's fire alarm system.

Fire Protection System Riser Check Valve and Gate Valve

- 4. Scope existing sanitary sewer system to determine sizing, inverts, and condition. Confirm location and size of grease interceptor and have it cleaned.
- 5. Provide new ADA compliant plumbing fixtures in the public restrooms. Water closets shall be vitreous china, floor mounted with sensor operated flush valve. Urinals shall be wall-hung, vitreous china with sensor operated flush valves. Lavatories shall be vitreous china with single lever faucet. All fixtures, faucets, flush valves shall be of the water saving type.
- 6. Provide the existing sprinkler riser with (1) flow, (1) tamper, and (1) pressure switch. Each one of these shall be wired to the fire alarm control panel.

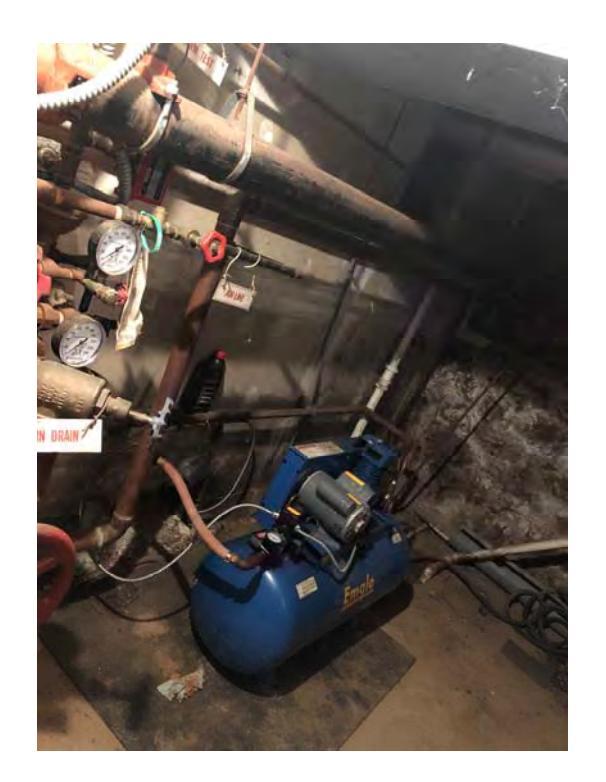
Fire Protection Air Compressor

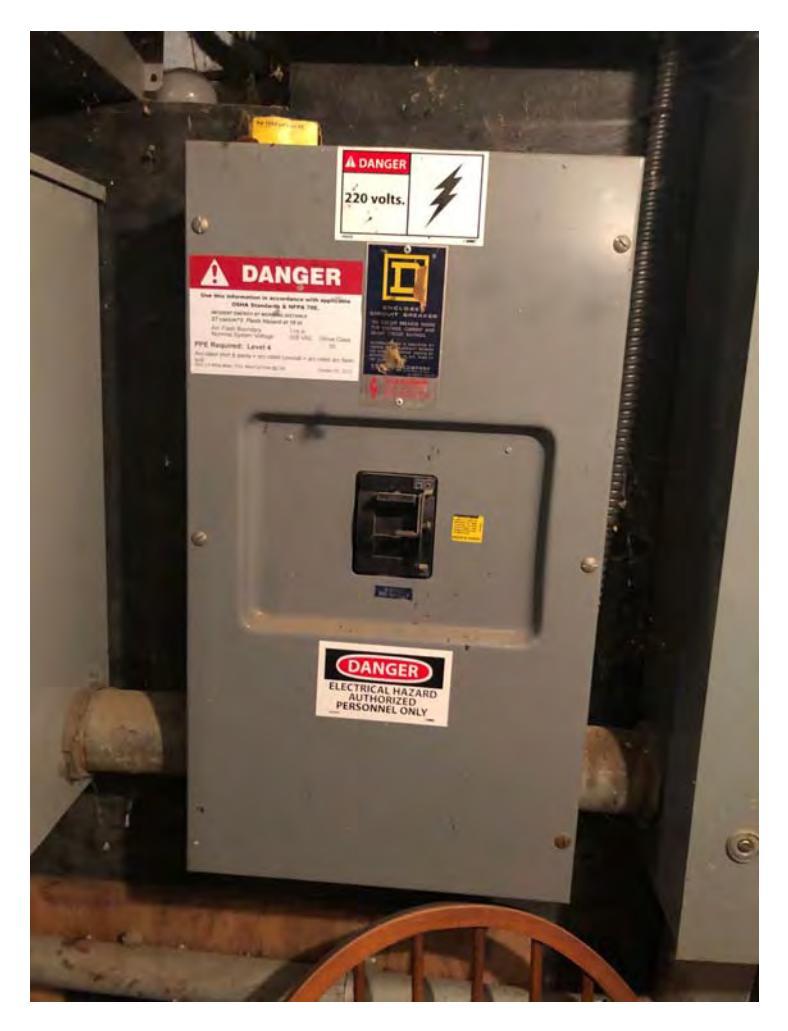
feeds the Main Distribution Panel, MDP. The CT cabinet, Main Circuit Breaker, and MDP are in good condition and may be reused. The MDP is a Square D I-Line distribution panel.

400A-3P Service Entrance Main Circuit Breaker

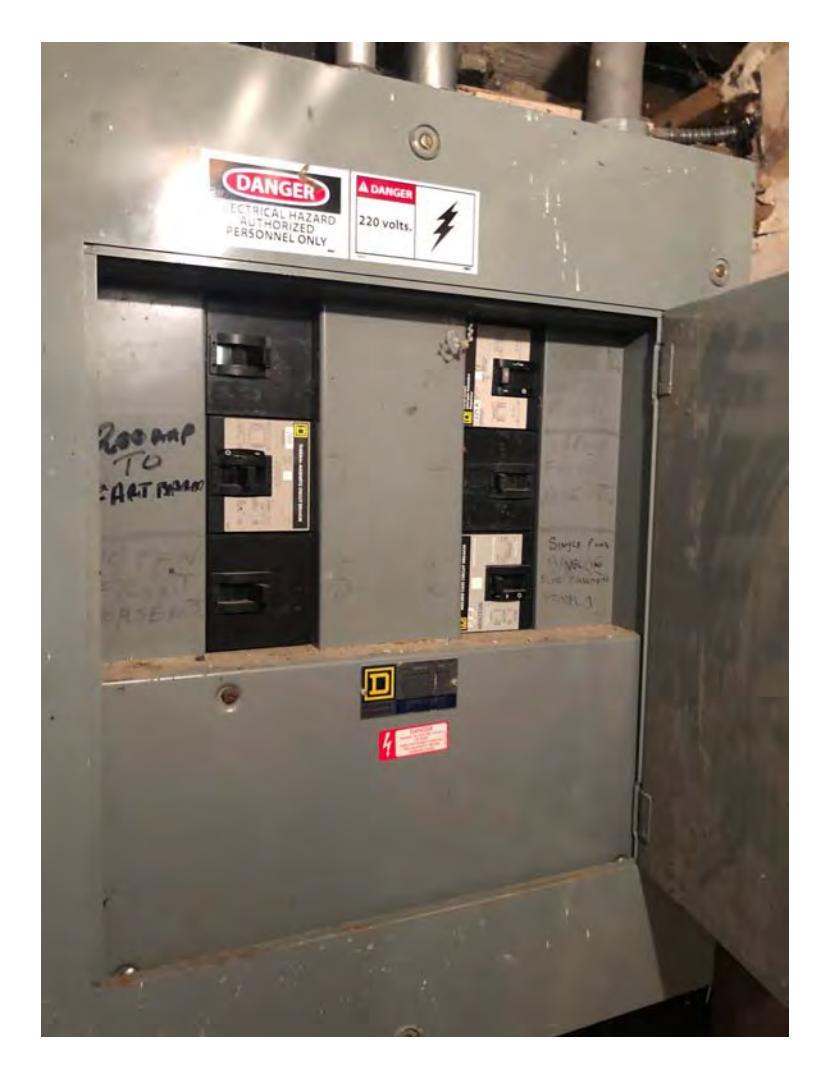
Square D I-Line Main Distribution Panel, MDP.

- 3. The Main Distribution Panel serves several additional panels, including three panels in the North Basement and two panels in the South Basement. These panels are in fair to good condition and can be reused.
- 4. The existing MDP is full and has not space for any additional distribution circuit breakers. There is an existing 200A-3P circuit breaker that feeds the Cart Barn. This circuit breaker is in the "Off" position.
- 5. These panels shall be used to feed all new loads in the space. There are several panels that are 208/120 volt, single phase, three wire. Three phase loads cannot be fed from these panels. Additional panels can be added as necessary to support the required loads.
- 6. The following is a list of the panels present in the building.
